Fermilab Mu2e status update

Daniel Ambrose

6/19/2015

Fermilab Status

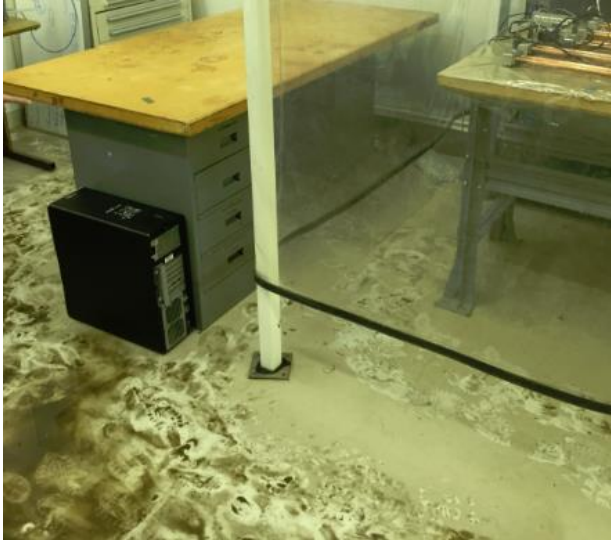
Monday night (6/15/15) Lab 3 Flooded.
1-2 inches of water everywhere including clean rooms.
Besides infrastructure very little equipment was destroyed.
We did lose our computer which was running Leak testing, but
data was already saved multiple places

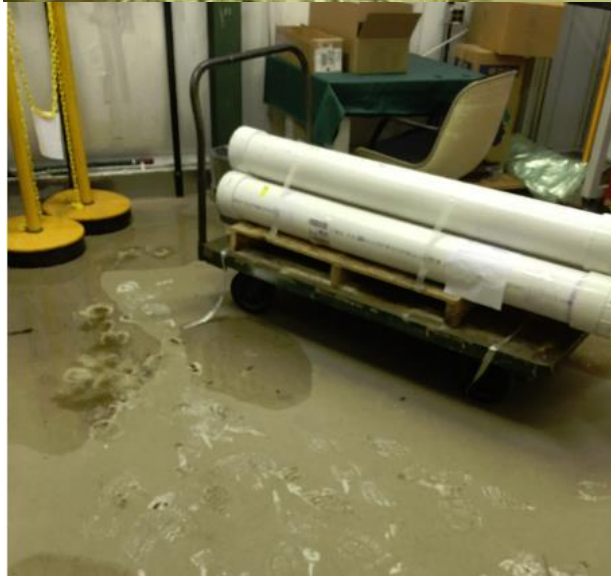
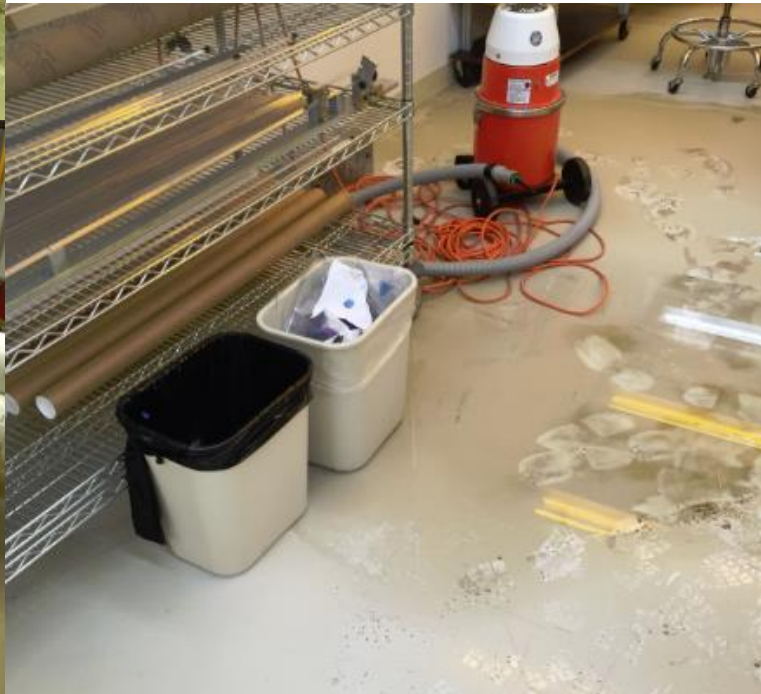
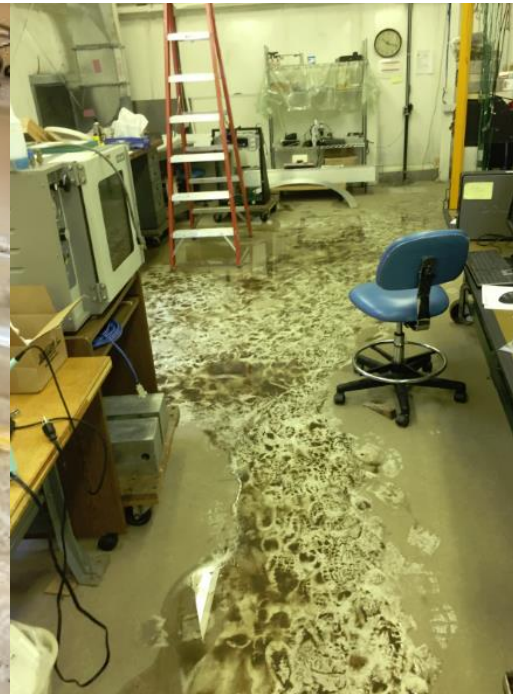
Lab 3 status

Lab 3 was cleaned in 1 day!

Looks like drywall will need to be replaced everywhere which will be done sometime in the future.

Cleanrooms won't be "clean" until drywall is replaced. Panel moved to MAB for epoxying leaks.
