Leak test update

University of Minnesota

Yan Ke

Aug 28th 2015

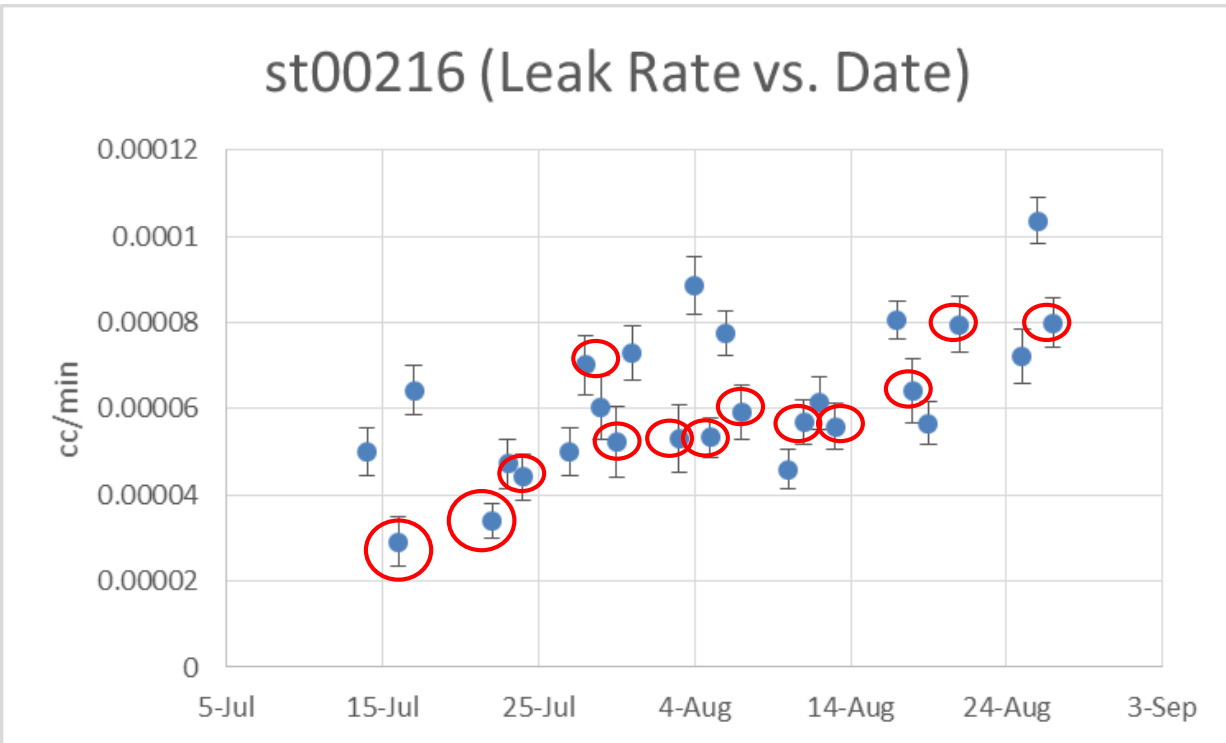
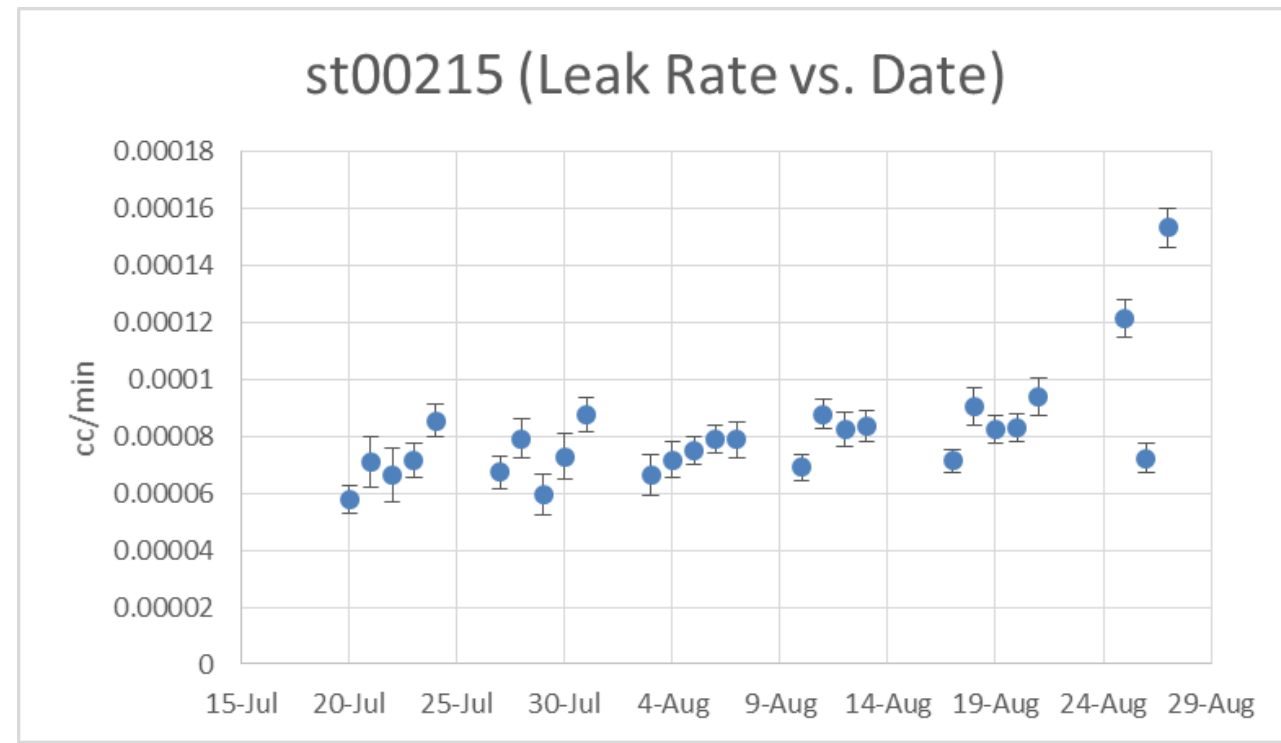
Consistency test result (replace viton)

The increase of the leak rate might be caused by the worn viton.
Will use new viton next week.

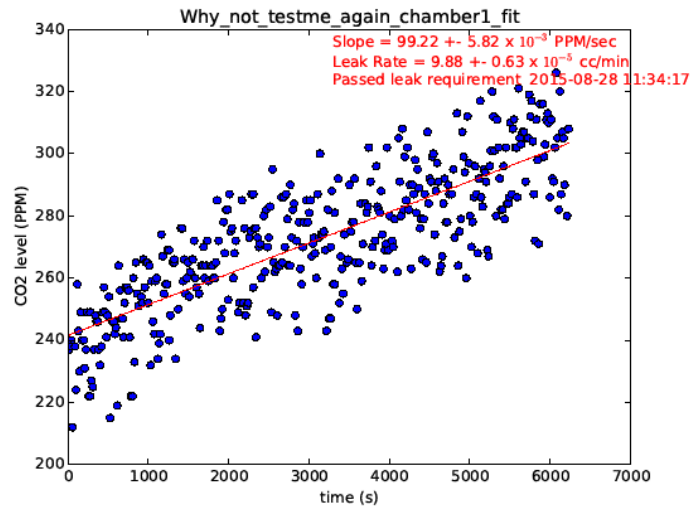
Figure1: The test for #1 box
ch#3 on next morning

- The kink maybe caused by the rusted copper inside the chamber. When the chamber was left open overnight, there will be chemical reaction between CO_2 and CuO . When tested straws the next morning, CuO release CO_2 which cause a step input of CO_2 . Then the kink happens.
- Test: Switched boxes between #1 and #3(the one has most of the kink) and left ch#3 open ch#1 closed with N_2 overnight.

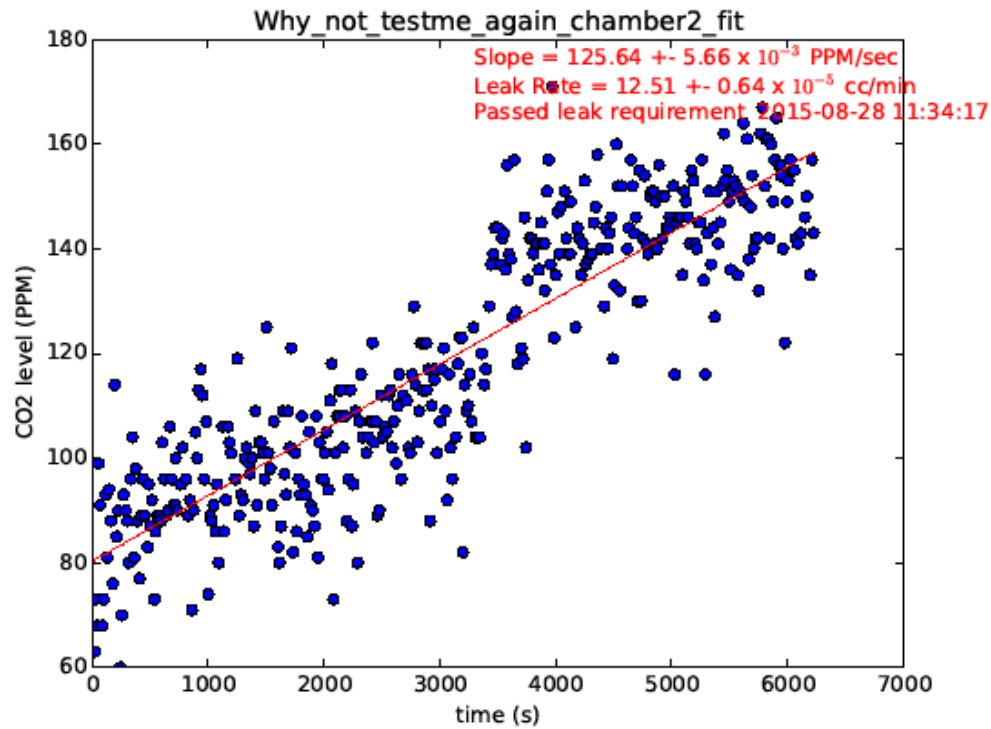
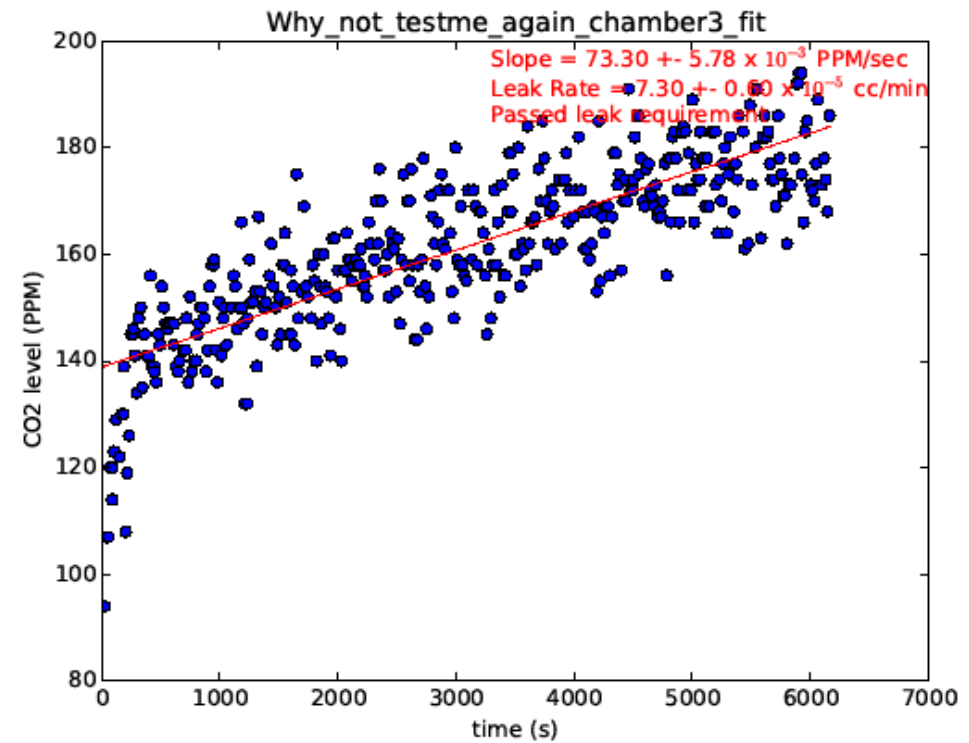
Jump in ppm value

- Maybe the figure on the right is not a kink. It's also a jump?
- Jump seems to be around 30ppm.
