Straw Assembly for CO_2 Leak Testing

Rice University

October 17, 2013

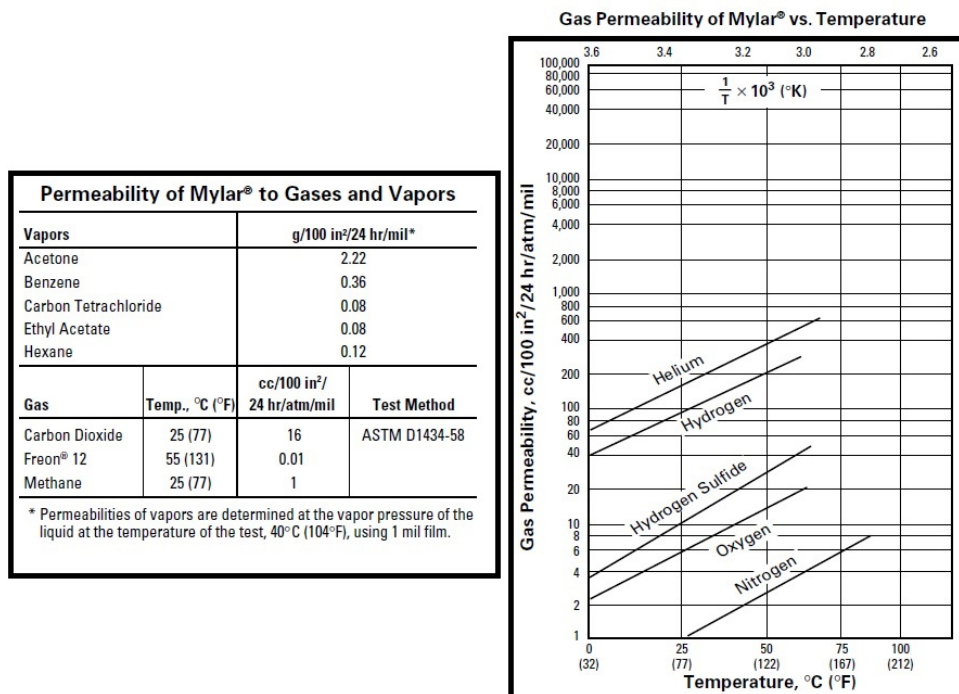
Figure 2: The chart depicts the gas permeability of Mylar® as a function of temperature. The straws will be filled with $ArCO_2$ while the chamber will be purged with N_2 . Mylar® is most permeable to carbon dioxide which is not included in the plot but whose value appears in the chart.

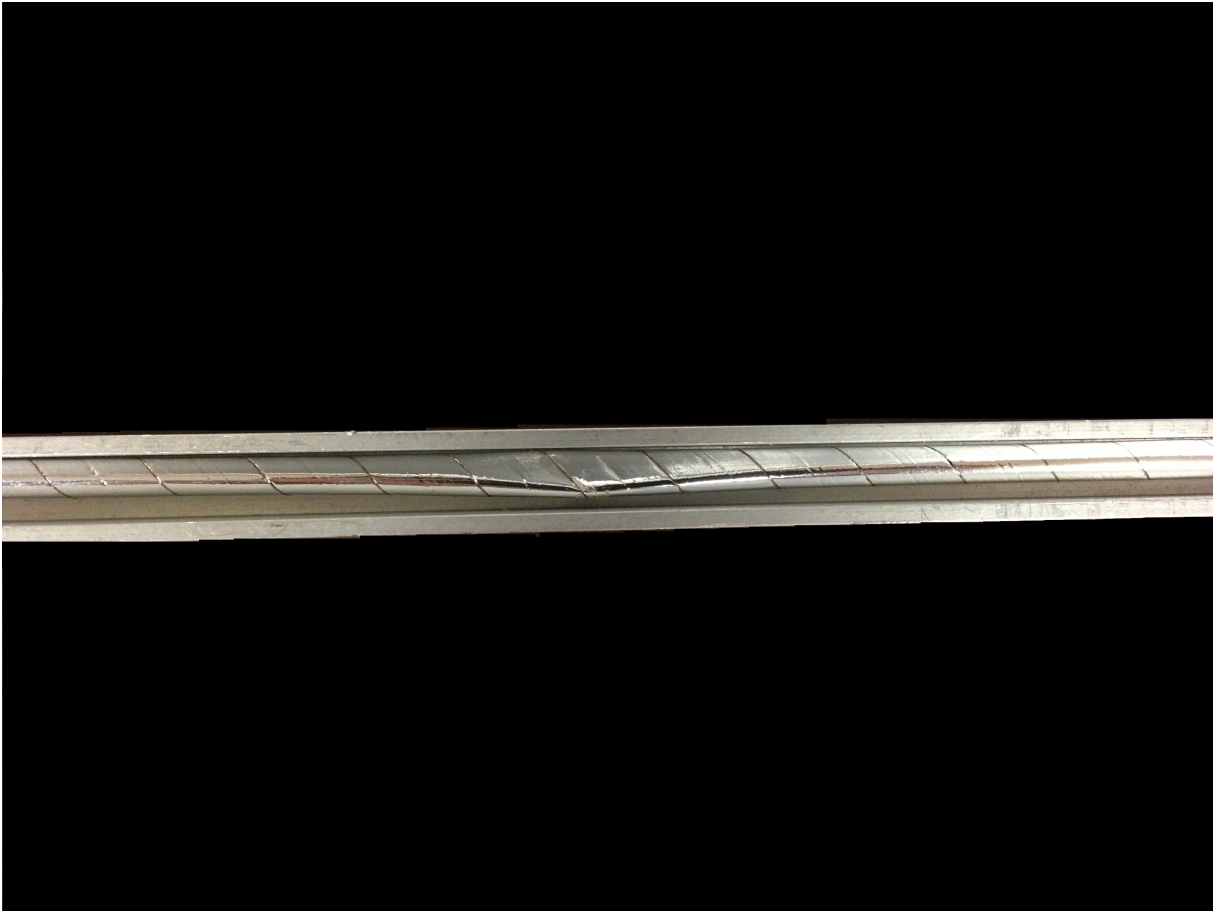
Figure 3: A straw that was left sealed over the period of a weekend.

Over a period of days, straws that had been left sealed had collapsed, see figure 3. We understood this effect was due to the larger permeation rate of CO_2 through the straws than oxygen or nitrogen, as can be seen in the chart in Fig. 2. The straws were flushed with $ArCO_2$ (80/20) hence the concentration of CO_2 within the straws should have been in the order of 200,000 ppm (parts per million). This concentration of CO_2 within the straw is high compared to the concentration of CO_2 in room air which was measured to be around 500 ppm i.e. 400 times less. Furthermore because Mylar® is permeable to CO_2 , impermeable to N_2 (at room temperature) and less permeable to Argon and Oxygen (relative to CO_2) there is a net outflux of gas from inside the straw, resulting in a partial deflation. Upon opening a hole in the 5-Minute epoxy seal using a hand drill, the straws did not regain their shape and were permanently deformed. This permanent deformation of course is not acceptable and should be avoided. Therefore: **straws should be kept open to air after they are leak tested or at least they should not be kept sealed for long periods of time (days).**

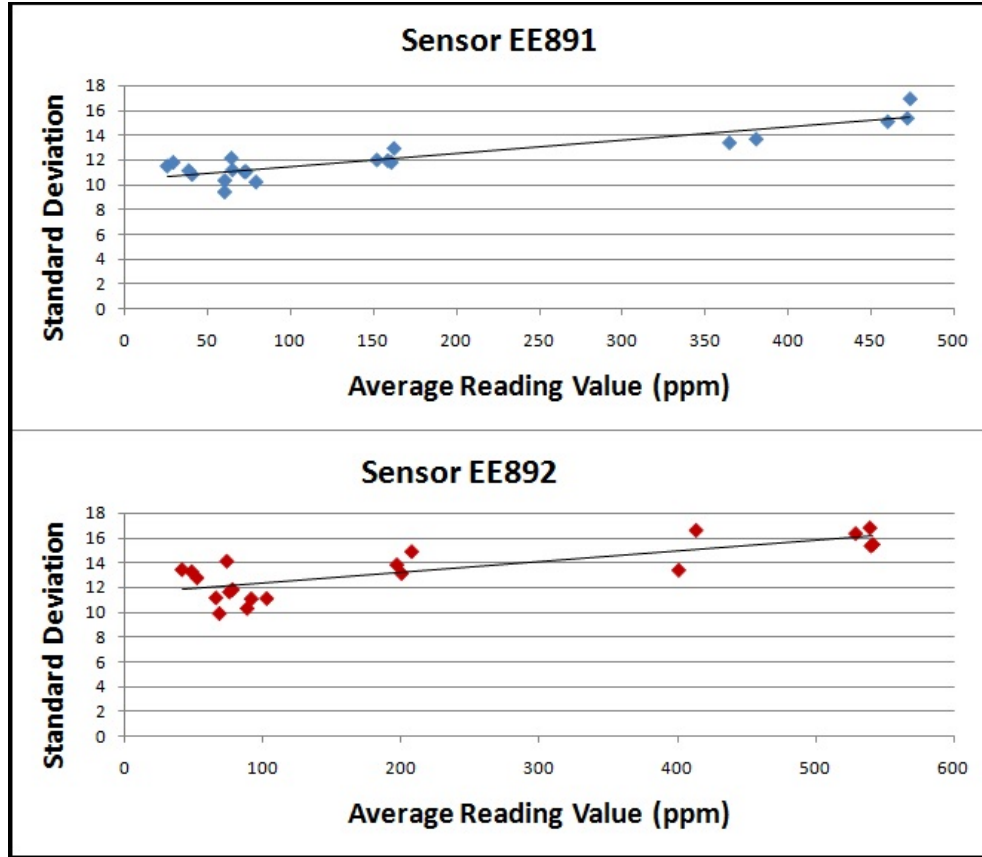
Figure 6: The linear models performed on these points estimate the standard deviation for the EE891 sensor (σ_1) to be $\pm[(10.44 \pm 0.35)ppm + (1.02 \pm 0.13)\% \text{ of the Reading Value}]$ and $\pm[(11.45 \pm 0.45)ppm + (0.86 \pm 0.16)\% \text{ of the Reading Value}]$ (i.e. σ_2) for sensor EE892.

The original plan was to purge the chamber with N_2 and bring down the CO_2 levels to zero and ideally attribute the CO_2 readings to a leakage in the straws. It was found that purging our prototype down to zero was not practical because this took a large amount of time at high flow rates of N_2 and could not be reliably achieved. One of the main reasons behind purging is that the manufacturer quoted a dependency of the uncertainty of the readings on the reading value. The manufacturer of the sensors (E+E ELEKTRONIK) quoted the error in the sensor readings as being $\pm(50\text{ppm} + 2\% \text{ of the reading value})$. This direct dependency on the reading value suggests that the lowest errors are achieved for reading values equaling or those near zero. This was also visually apparent when comparing plots for which the reading values were high to those which were low. The spread in the plots increased as the reading value increased. The error quoted by the manufacturer was tested with our prototype chamber by plotting standard deviation vs. average reading value for segments of data (usually 1 hour long) which were flat. Figure 6 depicts the error as being less than what the manufacturer quoted but still dependent on the reading value.

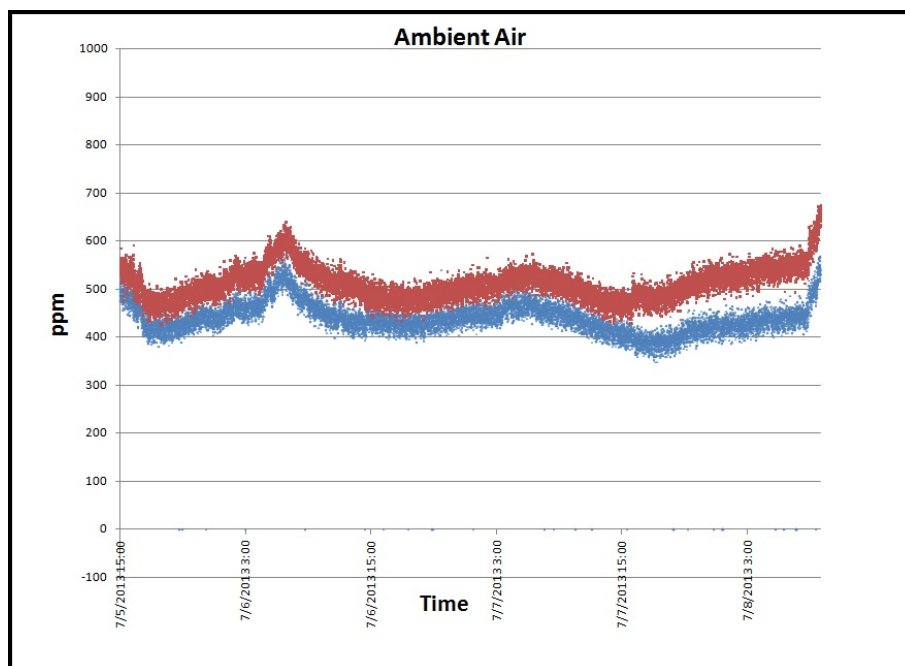
Figure 7: Readings logged for CO_2 chamber open to air over a few days.

To ensure that this was consistent with the experiment, three different backgrounds were considered: N_2 , dry air, and ambient air. The latter was discarded as a possibility due to its instability. To test this option the chamber was simply left open and was set to record values over a few days after which we obtained the plot in figure 7. Ideally we want to perform the exact same leak tests with all the straws so this was unacceptable. A bottle of dry air was available to us so we were able to perform a test with it. Dry air has a higher CO_2 content and because it is bottled it can be controlled just as easily as N_2 . The results for the tests with dry air were consistent with a reading value dependency on the spread of our data. N_2 is the best candidate among the three for a background in our leak tests. It can be obtained easily and it is cheaper, it can be used to purge leak testing chambers down to near zero easily, it is cheaper than dry air, and according to the graph in figure 2 it does not diffuse significantly through Mylar® at room temperature.

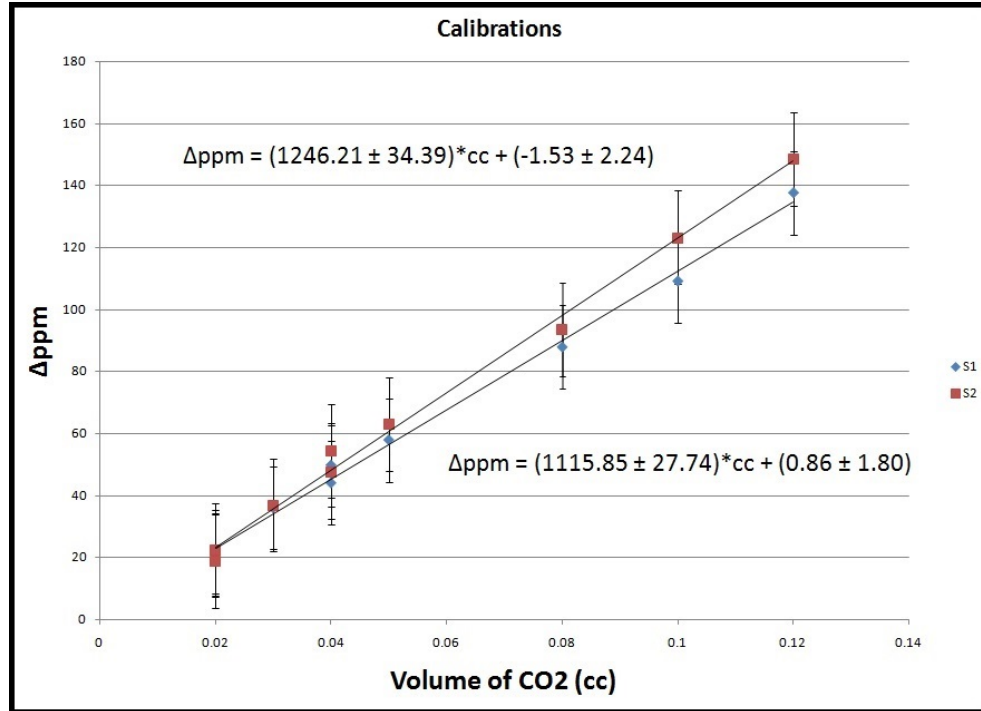
Figure 9:

The equations for the two lines in figure 9 are in the form of

$$\Delta ppm = m \times cc \text{ of } CO_2 \text{ injected}$$

Where m is the slopes of the least squares regression lines, and where Δppm is related to the volume of the chamber by the equation:

$$\Delta ppm = \frac{cc \text{ of } CO_2}{Volume \text{ of Chamber}} \times 10^6$$

$$\text{Hence } \Rightarrow Volume \text{ of Chamber} = \frac{cc \text{ of } CO_2}{\Delta ppm} \times 10^6$$

Because the chamber was setup before measuring all of the necessary dimensions to calculate the volume accurately, we would like to use these formulas to calculate the volume with a higher degree of confidence. Upon calculating all of the different volumes predicted by these models and taking the average of these, the volume was calculated to be (884.7 ± 15.6) cc from the values of Sensor 1 and (843.5 ± 29.9) cc from the values of Sensor 2 both of which vary significantly from 733 cc which was the earlier estimate. Based on the 9 calibrations performed we can say that we are 95% confident that the interval $(848.6, 920.8)$ contains the true value for the volume of the chamber. Taking more measurements would help narrow down this interval but we can *confidently* say that the chamber is actually slightly bigger than originally thought and that therefore the leak rates calculated utilizing the old estimate for the volume are a bit lower than the actual leak rates of the straws. It is *highly* recommended that a similar series of calibrations be performed on any future chambers assembled for the purpose of leak testing straws.

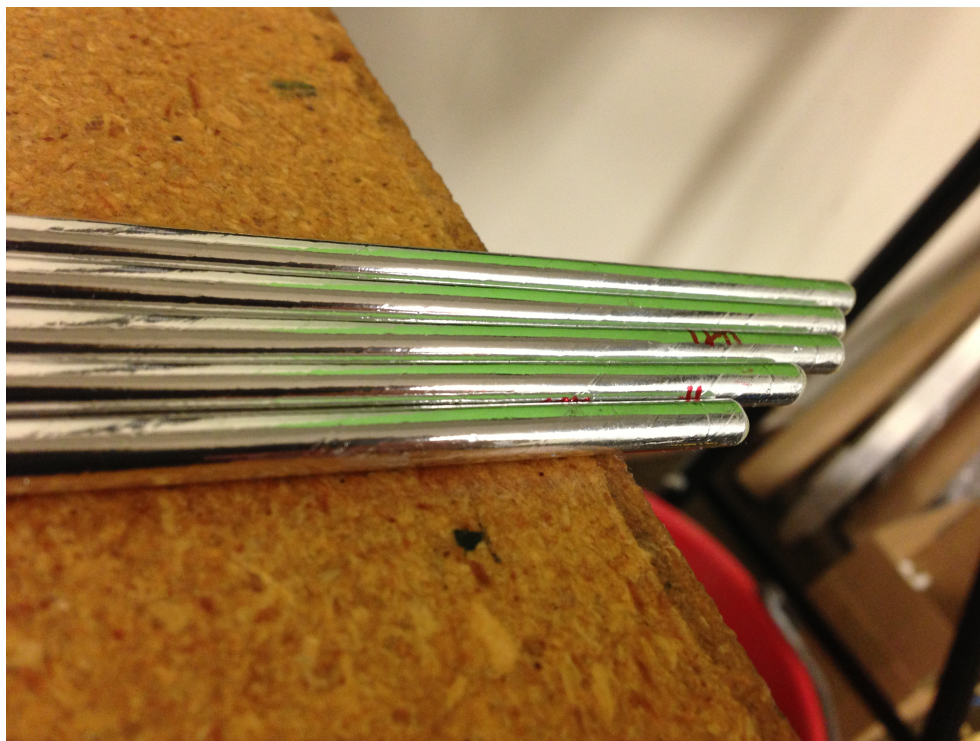
Figure 10: PPG Straws

The first leak tests performed on PPG straws were done on the seven straws, five of them as seen in figure 10. These straws had been previously used for other tests and had brass end pieces epoxied on both ends which were cut off before using. Some of the straws showed signs of creasing although most were only small wrinkles in the body of the straws. The straws were prepared by plugging with the old end pieces, flushing with $ArCO_2$, and sealing with 5 minute epoxy. The first batch of seven was prepared all at once and within an hour hence the same batch of 24 hour epoxy was used to attach the

end pieces. The straws varied in length, but only by a few inches with the shortest straw being 53 inches and the longest being 56 inches long. They were labeled 1-7 in order to keep track of each straw individually. They were flushed and sealed with 5 minute epoxy just before being placed in the chamber to avoid deflation.

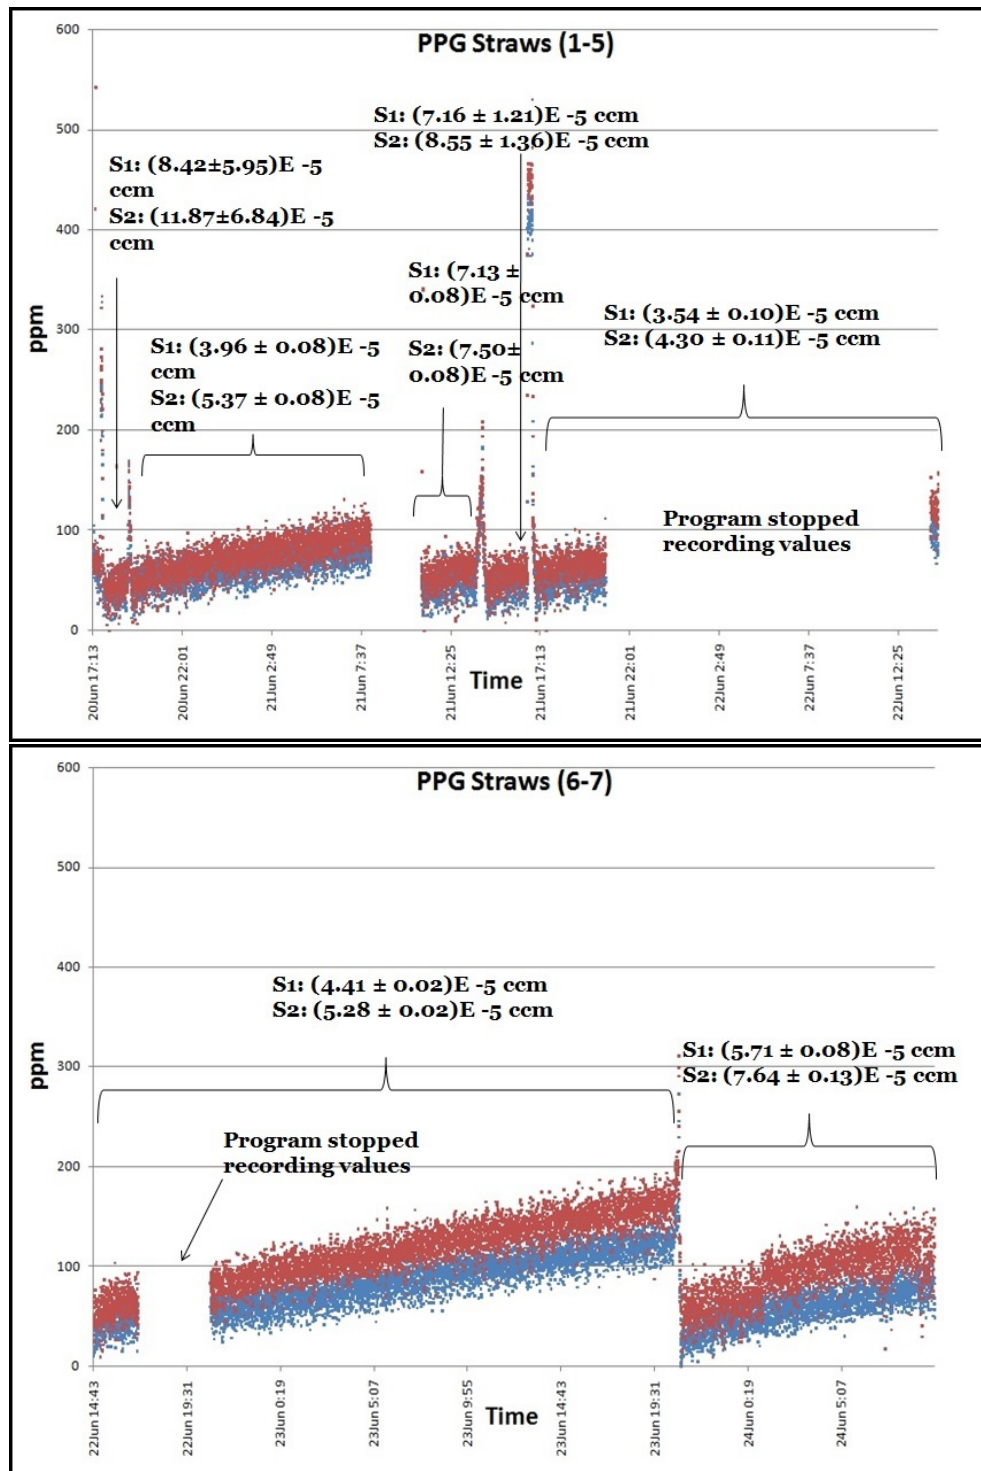
Figure 11: Plots of PPM vs. Time for the first set of PPG straws tested.

Linear Least Squares Regression lines were approximated using the data corresponding to each individual straw and then the leak rates were calculated based on the slope of the regression line that Excel calculated. The slope for the line that Excel put out was in units of ppm per day hence the leak rate was derived by relating this concentration over time to the estimated volume of the chamber. The slopes have been revised to account for the discrepancy in the volume of the chamber. The volume was assumed to be the average volume from the calibration calculation based on Sensor 1, i.e. 884 ccm, which had the lower spread. Even after the leak rates increased by about 20% due to the error in the volume none of the leak rates were over the limit and, furthermore, even in the worst case scenario the maximum slope was $18.71 \times 10^{-5} \text{ ccm}^6$, corresponding to the first straw tested and appearing in figure 11 which is still well below the limit. To obtain the leak rate we then subtract the background for this set of straws which was calculated a couple of days prior to be $(2.41 \pm 0.06) \times 10^{-5} \text{ ccm}$ and which can be seen at the top of figure 11. Hence the maximum leak rate in the worst case scenario would be $16.30 \times 10^{-5} \text{ ccm}$, which is less than half of the maximum leak rate allowed for each straw. Additionally all of the straws will be shorter (33 in - 46 in) than the length of the straws we tested so we can expect lower leak rates in the shorter straws due to less Mylar® for gas to diffuse out.

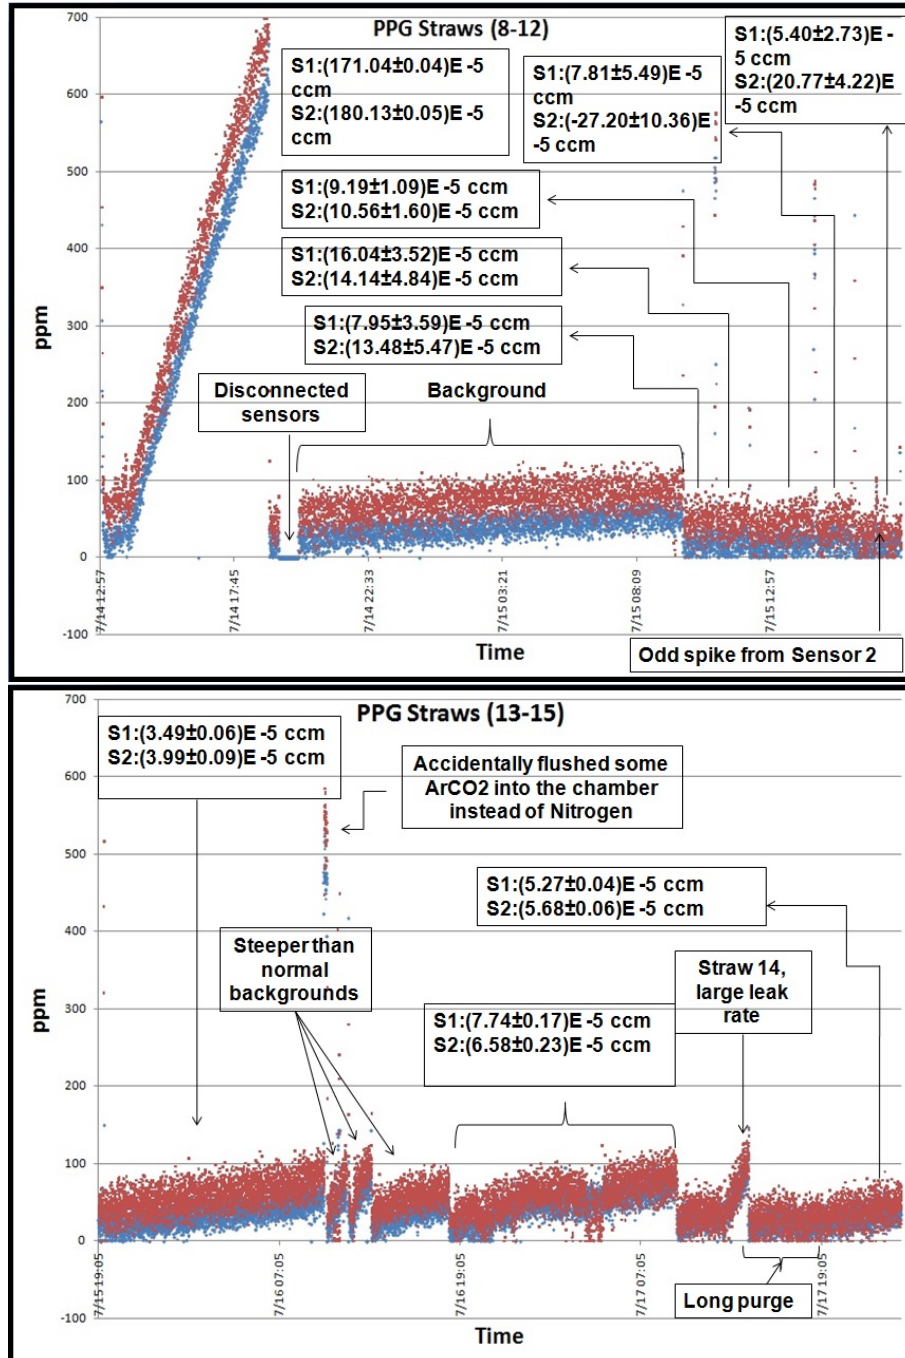
Figure 12: Second Set of PPG Straw Leak Rates

The epoxy cured at room temperature for an hour while the pieces were being attached on all 8 straws, once the working time for the epoxy had expired the ends were heated for four hours using heating pads after which the straws sat at room temperature over a day until they were used. Straw number 8 was flushed with ArCO₂ for about 5 minutes and was sealed using 5 minute epoxy. It was inserted into the chamber and left to record over night. The straw leaked from the start at a steep rate of about 170.1×10^{-5} ccm (Sensor 1) and 180.0×10^{-5} ccm according to Sensor 2 (see first . Upon inspection, there was a small lip on the straw which had not glued well to the end piece while insert-

ing it. This possibility that this was the source of the leak was tested and confirmed by generously adding another coat of epoxy to the ends and specially around the edges of the straw and then monitoring the leak rate a second time. Something similar occurred with straw 14.

Straw 14 had a somewhat steep slope thus it was removed shortly after inserting into the chamber. Straw 15 was inserted into the chamber and the chamber was accidentally flushed with $ArCO_2$ and the sensors became saturated. Straw 15 was removed and the chamber was purged; however, even after purging, the CO_2 levels were rising abnormally fast. Straws 8 through 14 were reopened using a hot knife and a small hand drill to allow air to diffuse in and out of the straw without causing them to collapse. After purging two more times straw 15 was reinserted and leak tested over night. Because straw 14 had shown a higher than normal leak it was flushed again with $ArCO_2$ and then it was sealed again. Straw 14 was re-inserted into the chamber and a steep slope was again observed. The straw was removed and another coat of 5 minute epoxy was applied generously to the ends of straw 14 to ensure that they were properly sealed. The chamber was re-purged and straw 14 was inserted into the outflow tube. The leak rate was found to be low confirming that the ends were not properly sealed. On a separate note, in the process of opening the straw by drilling through the 5 minute epoxy was difficult to do without wrinkling the straws near the ends. Straw 14 was also a test in the resiliency of the straws, because it became very wrinkled while reopening it as seen in figure 13. Surprisingly the leak rates for this straw were some of the lowest in the batch hence we concluded that the the leak in straw 7 was mainly due to the poor seal between the straw and the end piece.

For this set of straws the background was measured to be $(3.42 \pm 0.10) \times 10^{-5}$ ccm. In the worst case scenario for this set of straws the maximum leak rate would be that of straw 10 which had a slope of 19.56×10^{-5} ccm. Taking into account the background, the worst leak rate would be 19.66×10^{-5} ccm which is below the limit. We can expect that the true value for this leak rate is lower than this because the interval of time recording values for this straw was relatively short (an hour and 4 minutes). The same is true for most of these straws which only spent approximately an hour in the chamber and hence had higher uncertainties. We are, however, confident that the leak rate for these straws is bounded from above by the slopes calculated here with the exception of straw 12 who's approximate slope was negative according to sensor 2. There sometimes occurs a glitch in which sensor 2's readings which causes a shift in the reading either up or down. For this reason and because the error is perpetually larger for sensor 2, it would be best to use only the EE891 model of the CO_2 sensors (the newer model).

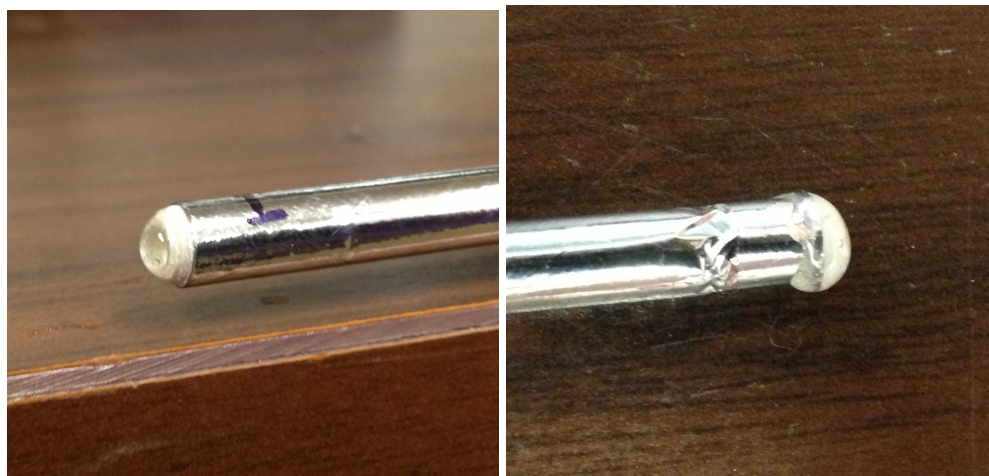
Figure 13: Cutting and drilling through the epoxy can wrinkle the ends of the straws if they are not held firmly where the end piece is. The two pictures are also before and after pictures showing how the leaky straws tested were coated generously to rule out the ends as the source of the leak.

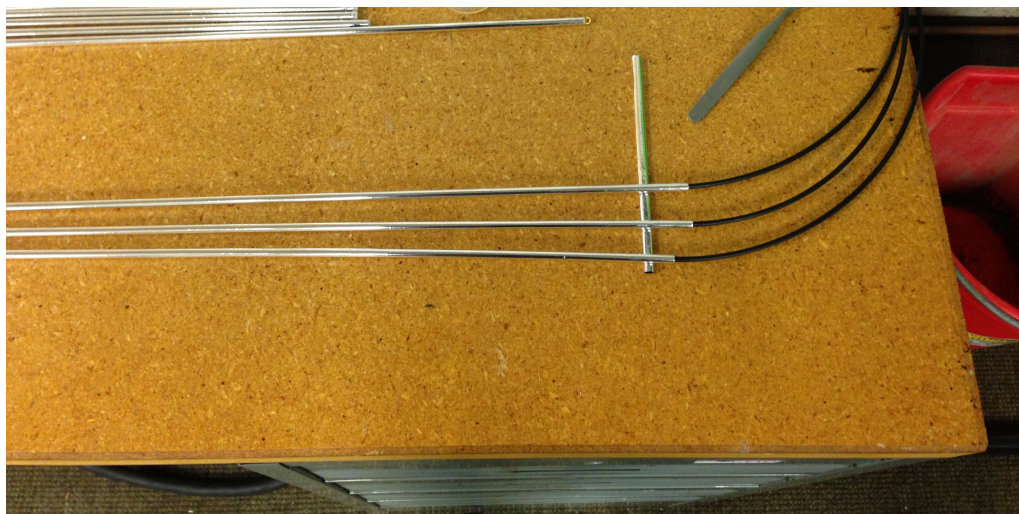
Figure 14: PPG straws with attached tubing for pressurized leak tests.

Initially a straw segment was tested prior to using pristine PPG straws by sealing them and attaching 1/8 inch tubing to the end piece to make it easier to pressurize. The 1/8 inch tubing was found to be appropriate because the end pieces have two holes one of which is larger than the other hole and which could be easily drilled to the proper size of the tubing using a drill bit. Regularly the end pieces are epoxied in place with the narrow hole facing out of the straw; however, since the tubing had to be on the exterior of the straw the end piece with the tubing had to be inserted backwards, i.e. with the narrow hole facing the interior of the straw. The second end piece was epoxied normally and the straw with the tubing attachment was placed on the heating pads which were set to the max voltage on the power supply (40 volts vs. the usual 17 V). Once the epoxy had cured, the straw was sealed on the end opposite to the tubing, and the tubing was connected to the gas line. For a better connection between the tubing and the gas line a 1/8 inch ferrul was placed on the tubing, and it was fastened with stainless steel connectors. The straw was then flushed with N_2 until the pressure gauge on the gas line reached the maximum level (14.7 psi or about one atmosphere above atmospheric pressure). The straws were notably stiff when at this pressure; however, the connection between the gas line and the straw was not quite as good, hence pressure dropped fairly

The test straw was found to withstand 2 atmospheres of pressure, so we proceeded to find a way to seal them in order to keep them pressurized and be able to insert them into the chamber. It was resolved that the tubing could be melted off and clamped to form a seal which was easy to open up. For a comparison between pressurized and unpressurized straws the straws were tested twice. First they were tested unpressurized by flushing with $ArCO_2$ (80/20), sealing the open end with five minute epoxy, waiting for the epoxy to cure (about 10 minutes), clamping the tubing with pliers, and melting off the rest of the tubing attached to the gas line. The tubing was sealed by clamping the melted portion of the tubing while still hot with a separate pair of pliers. The tubing was cut according to the length of the straw, i.e. so that the straw plus the tubing could fit into the CO_2 chamber. It was noted that the straws were easier to handle once pressurized since they become notably stiff. The straws were placed into the chamber and the chamber was purged down as usual. The straws are easier to handle once pressurized since they become notably stiff. Three straws were assembled and tested in this manner and additionally the last two straws to be tested were kept sealed while the first one was opened to air by simply cutting into the tubing with a sharp razor blade. The second straw lost some pressure during the sealing process thus the pressure inside the straw was below the target. The straw that collapsed completely during the vacuum test collapsed after about a day and a half; however, the set of straws prepared for these pressurized tests qualitatively showed no signs of deflation or pressure loss after the same amount of time.

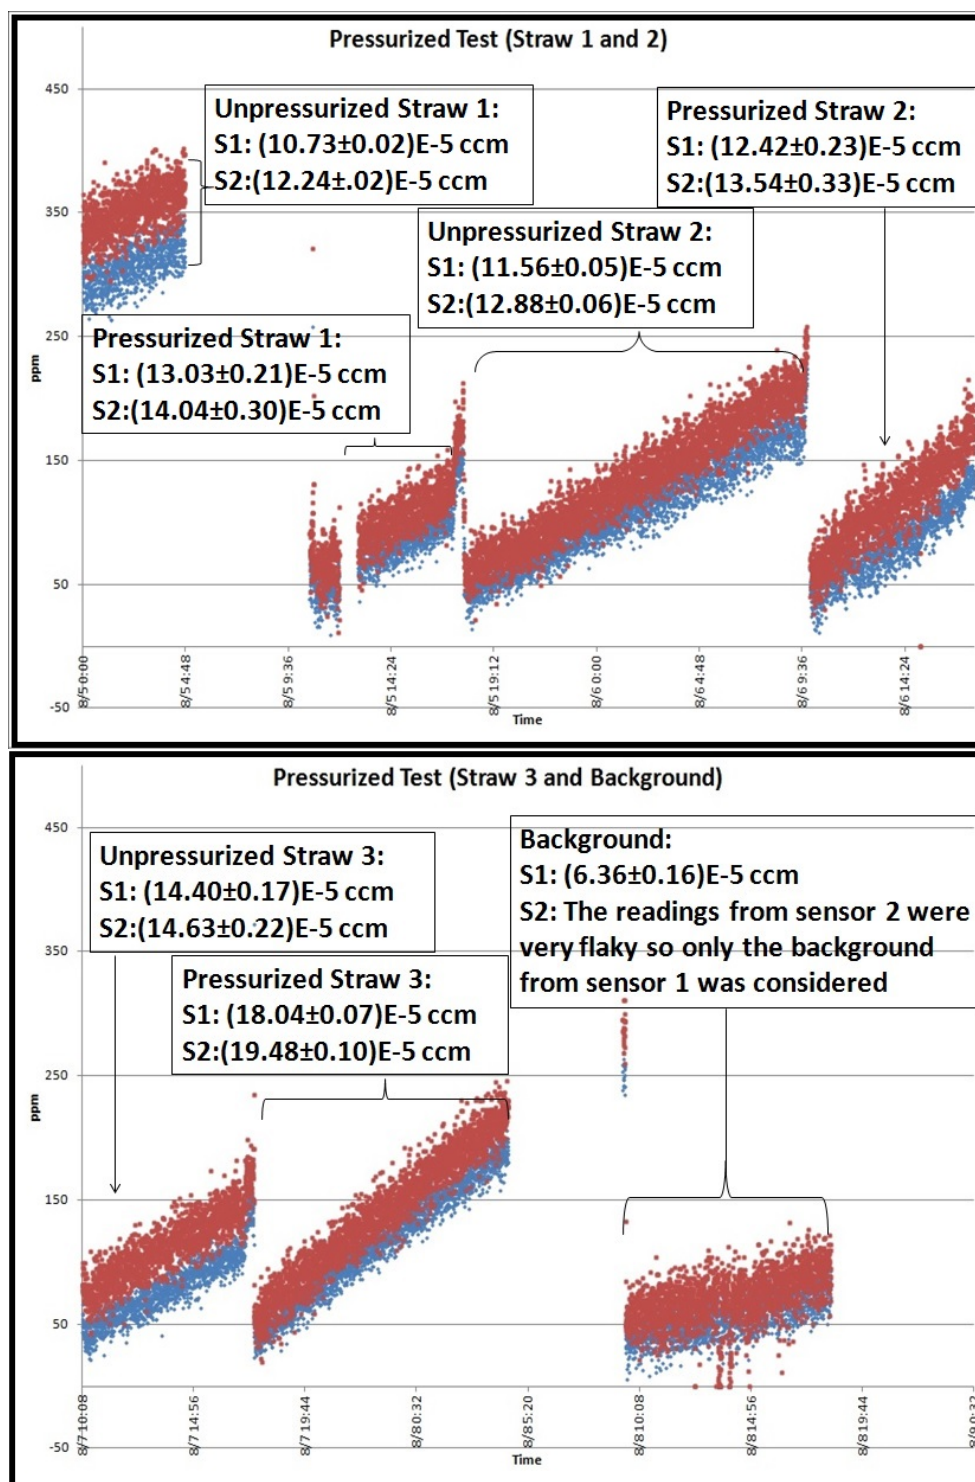
Figure 15: Pressurized leak rate tests performed on PPG straws.

The background for the set of pressurized straws was measured to be about $(6.36 \pm 0.16) \times 10^{-5}$ ccm by the readings from the first sensor. The second sensor appeared to have random fluctuations as seen in figure 15 thus the background from sensor 1 was utilized to calculate all leak rates in this set. The unpressurized test served as a comparison to the previous PPG straw tests. The leak rates for this set were between 4.52×10^{-5} and 8.53×10^{-5} ccm while the pressurized leak rates ranged between 6.32×10^{-5} and 13.30×10^{-5} ccm. We expected the leak rates for the pressurized straws to increase by

a factor equivalent to the ratio of the pressure in these straws to atmospheric pressure (ideally this would be a ratio of 2:1). What was observed, however, was a factor of about 1.53 for the first straw, 1.17 for the second, and 1.45 for the third. As expected the leak rate for the second pressurized straw was less than with the other two which were sealed without losing much pressure. As in previous tests the leak rates were safely below the proposed limit; although, they were higher than the leak rates measured for the same straws for the unpressurized tests, as expected.
