Mu2e CO2 Leak Test Update

University of Minnesota

Aug 10th

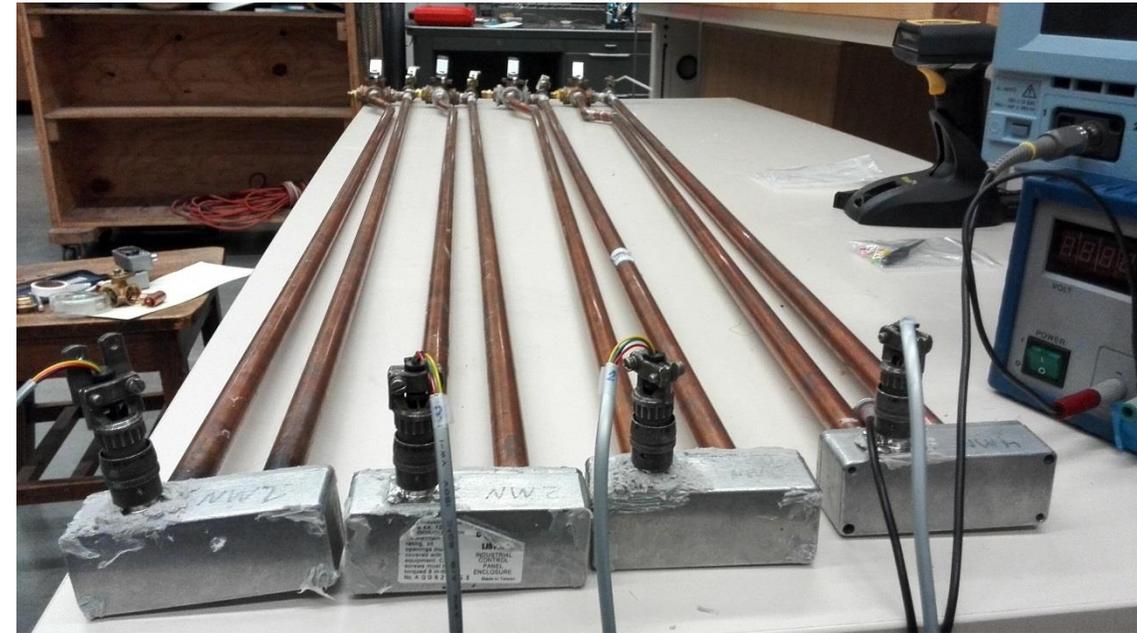
Apparatus at UMN

- 4 working chambers can are being used for measuring leak rate.
- 5 detectors can be read simultaneously. The fifth chamber will be built this week. (The resistance between detectors and Arduino chip should not larger than 1 ohms, otherwise the detectors will be failed to read simultaneously)
- Bar code scanner and Dan Ambrose's bar code python program is working well now.
- Calibration test has been done on 4 chambers.

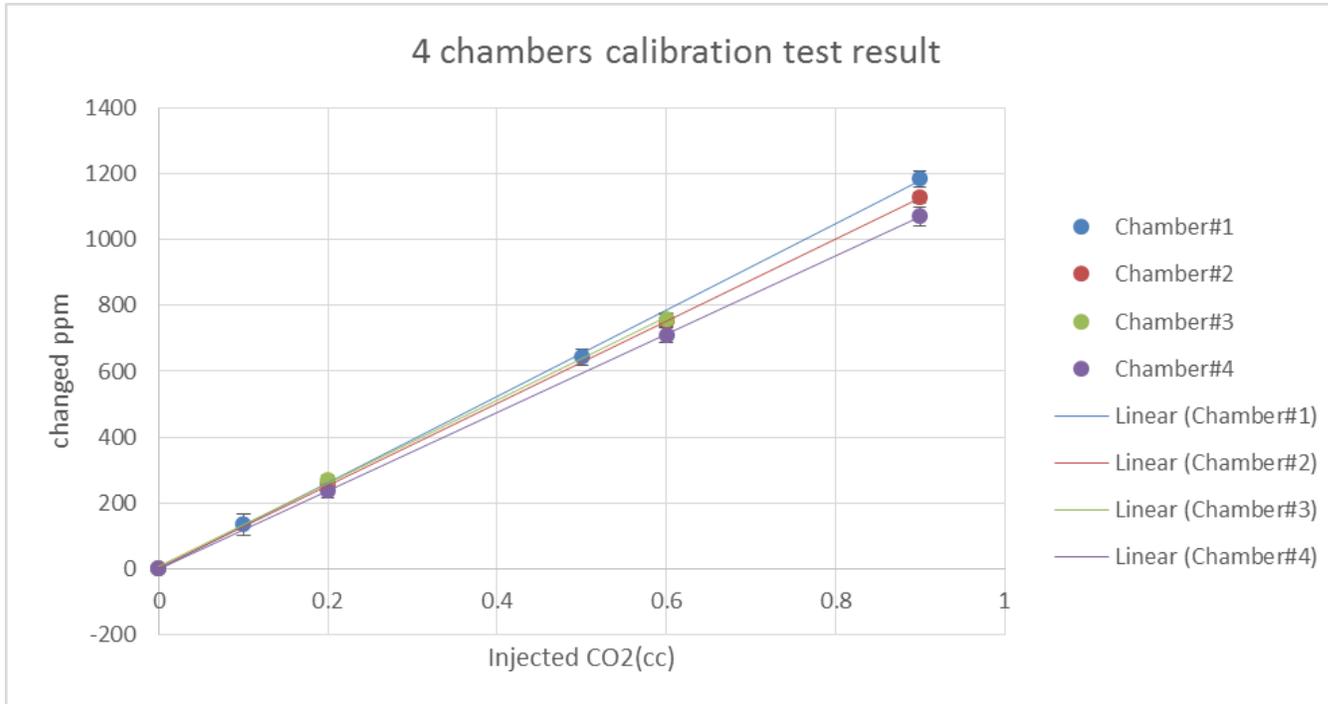
Calibration test results

- Volume been estimated by geometric method is larger than injection method.
- We will do the volume estimate using liquid method this week.

Results Without count in (0,0)			Results with(0,0)		geometric method
Chamber	volume	uncertainty	volume	uncertainty	volume
#1	380	14	382	7	466
#2	403	11	399	6	461
#3	407	19	391	9	454
#4	422	19	422	9	455

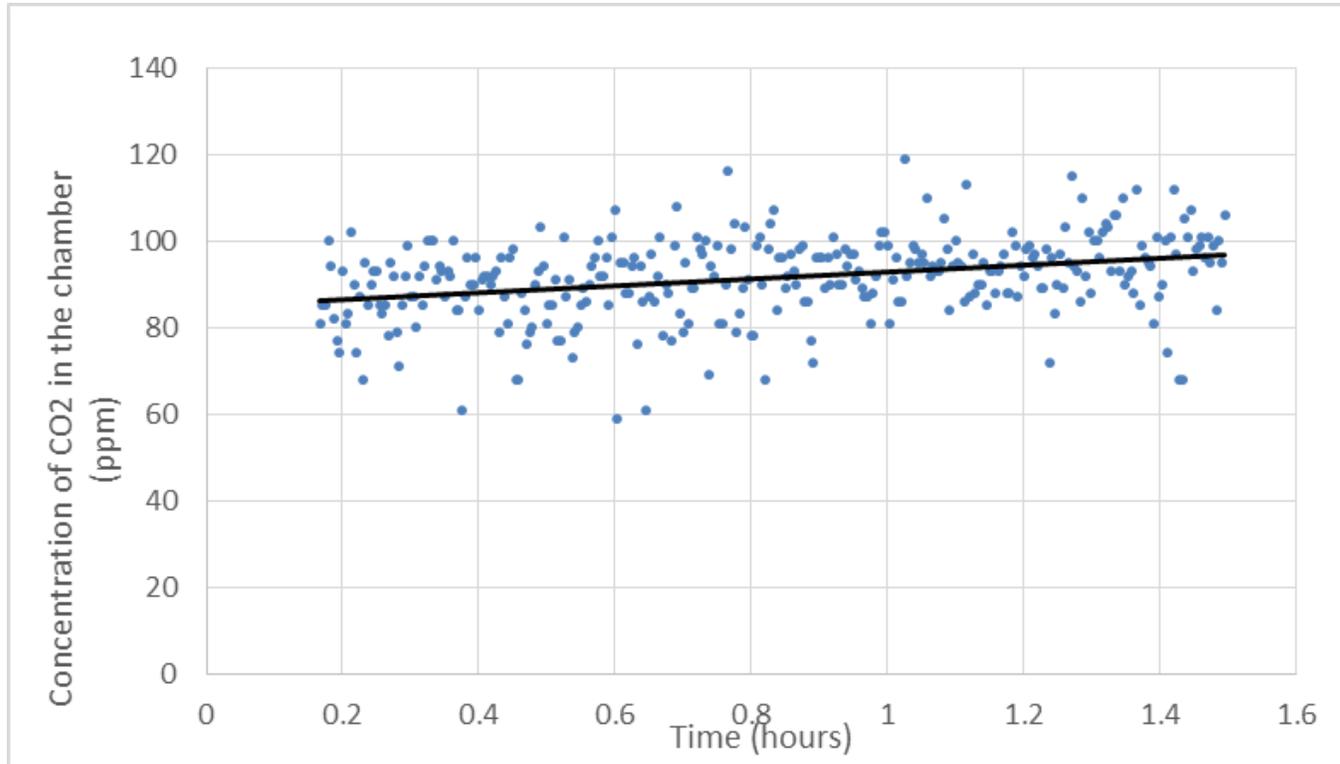
Viton is the main reason of the straw “memory”

- A straw was left to desaturate for 1 day after the measurement. Then it was tested after being sealed without flush with CO₂. The figure on the left shows the leak rate is $6 \times 10^{-5} \text{ cc/min}$ which means there is still CO₂ left inside the straw.
- Our guess is CO₂ left inside the straw let the viton keeps bathing in CO₂. Therefore viton cannot desaturate before CO₂ gone.

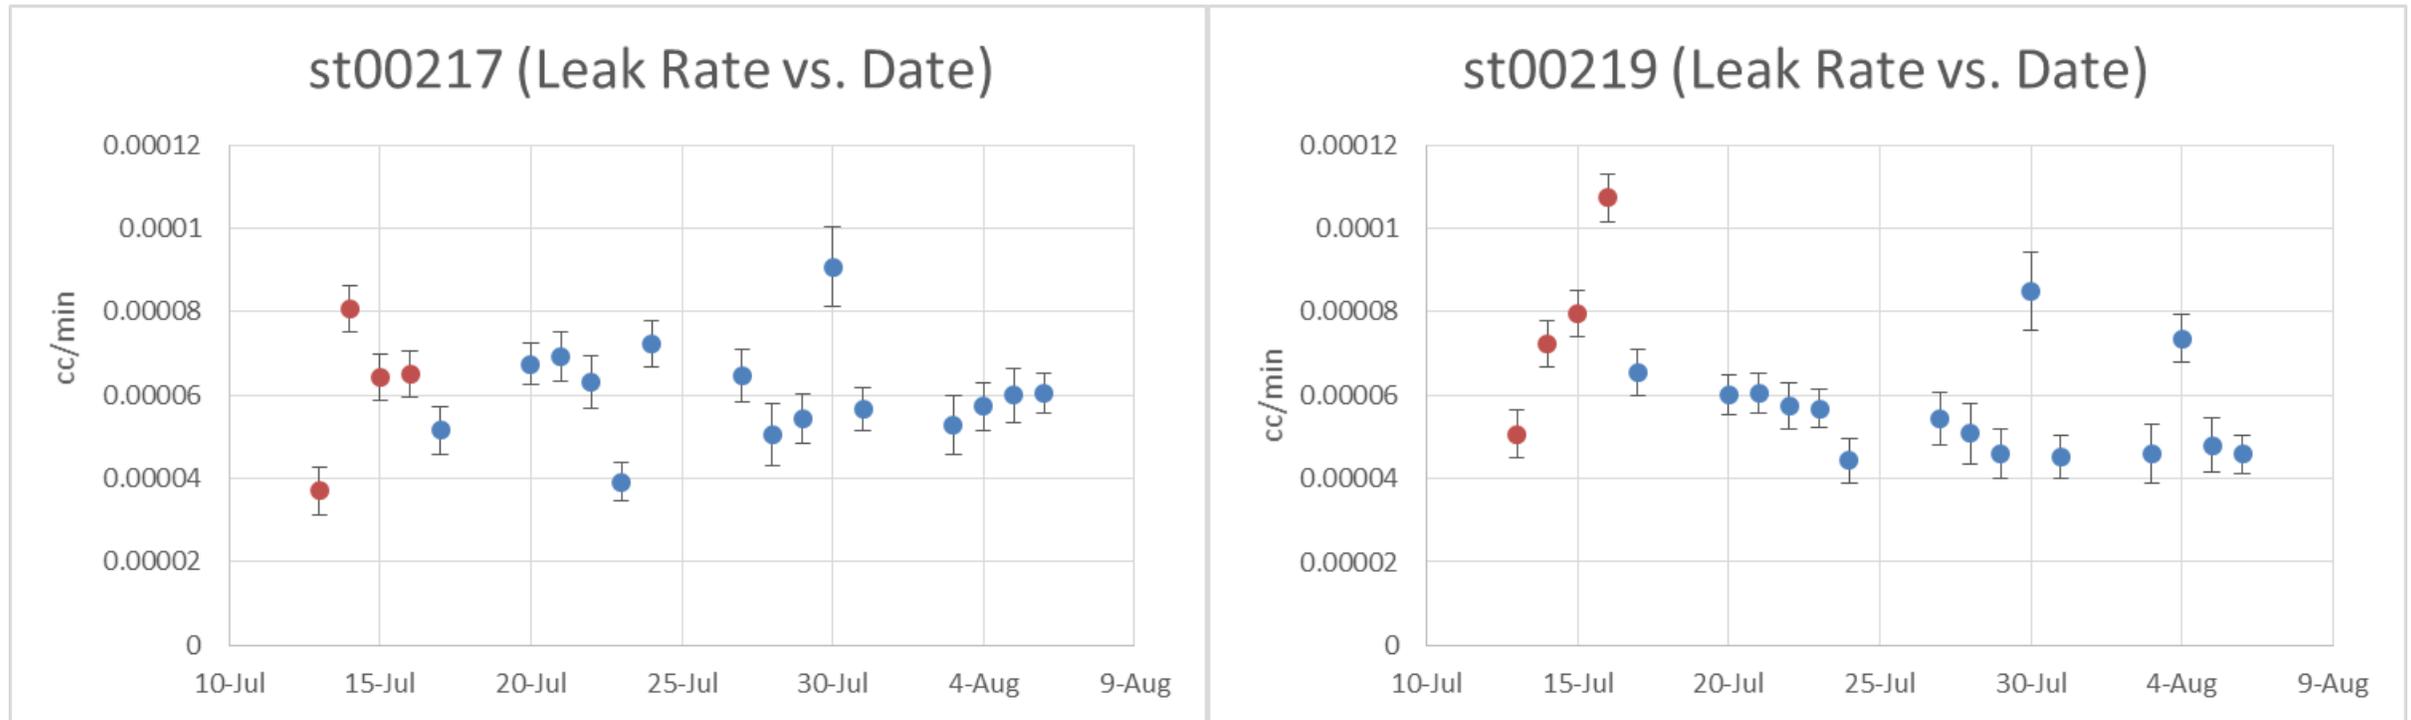
Consistency test result

st00217 standard deviation after been flushed N2: 1.2E-05

st00219 standard deviation after been flushed N2 :1.2E-05

- St00217 and st00219 have never been measured before these measurements.
- St00217 and st00219 has been flushed with N2 each time after measurement after the fourth measurement. Red points in figures show the result without flushing N2. Blue points show results with N2 been used.
- No memory things happened again if flushed the straws with N2.

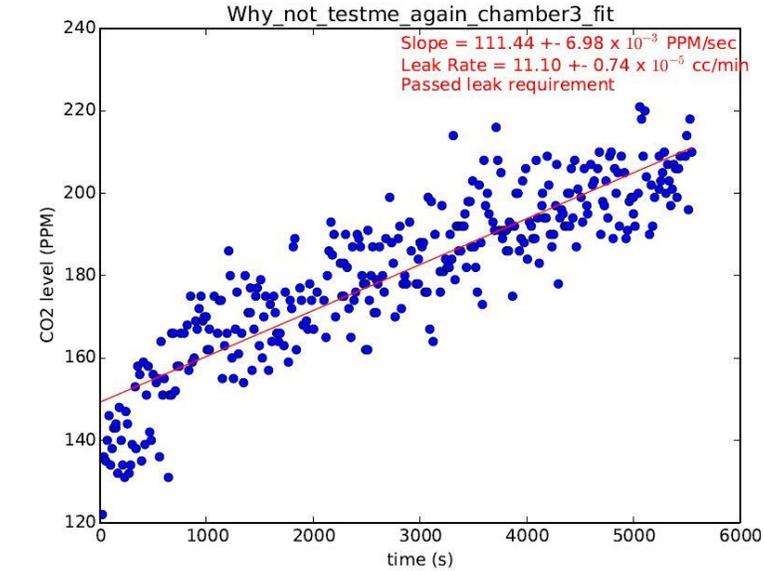
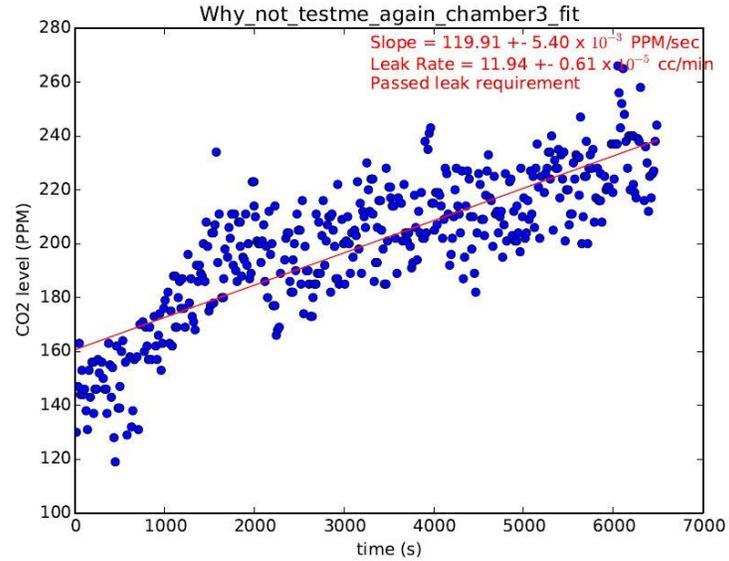
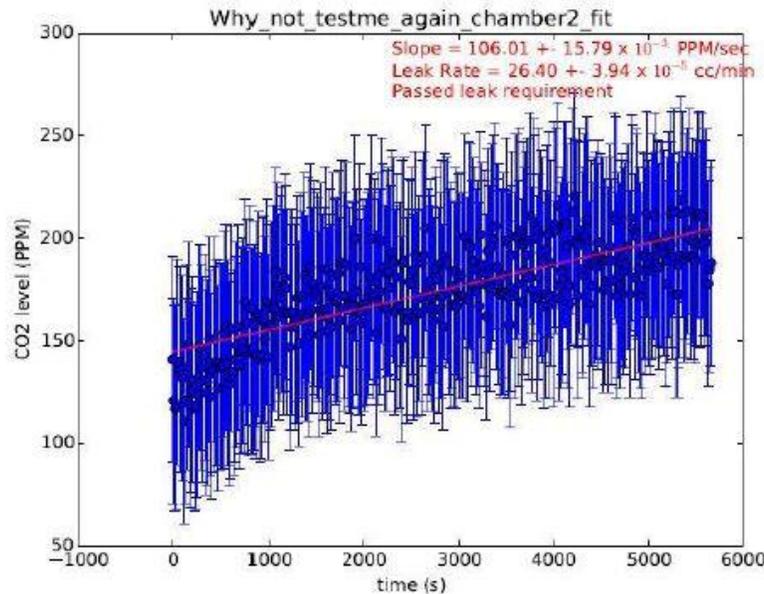
There are a few jumps

- Upper left: Jul 30th st00217
- Upper right: Jul 22nd st00217
- Bottom left: Jul 21st st00215 **leak rate should be divided by 2.5**
- The reason of “Jump” is unknown

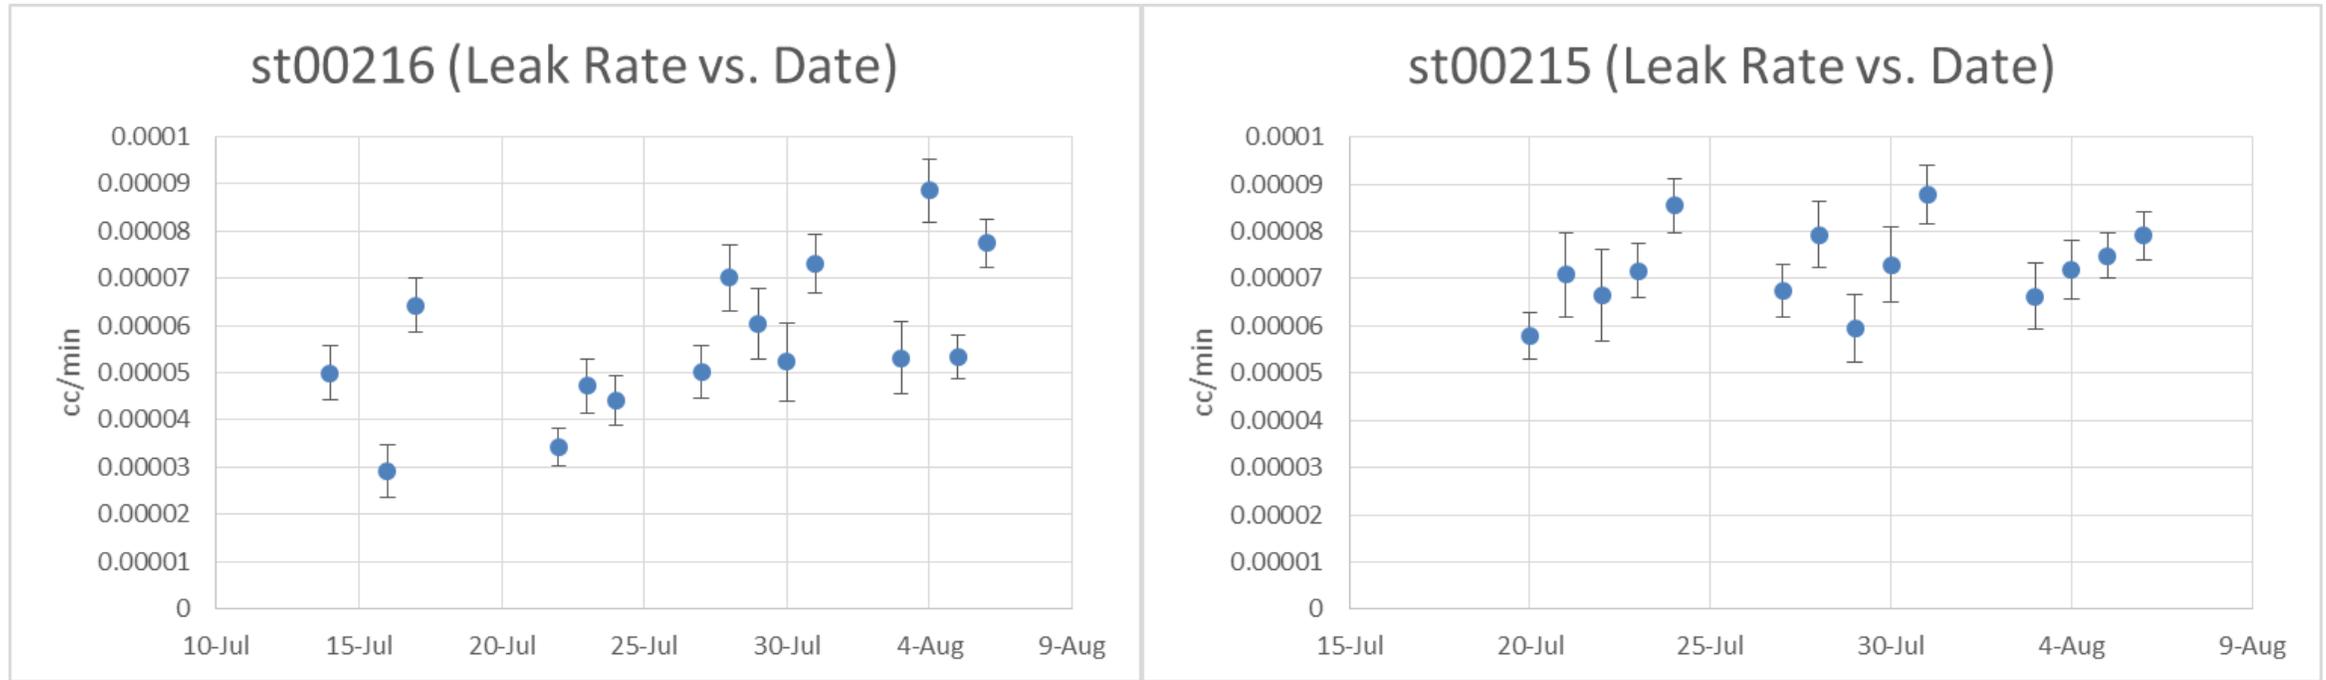
Consistency test result

st00219 standard deviation: 8.7016E-06

- St00215 and st00216 have never been measured before these measurements.
- St00216 has been replaced viton every other day. St00215 has been replaced viton everyday. Viton was left for desaturation for 1~2 days.
- The standard deviation of results by replaced viton is smaller than results by flushing with N2.
- Talk about the “memory” happened on st00215? If so, keep next slide. If not, place it after calibration test.

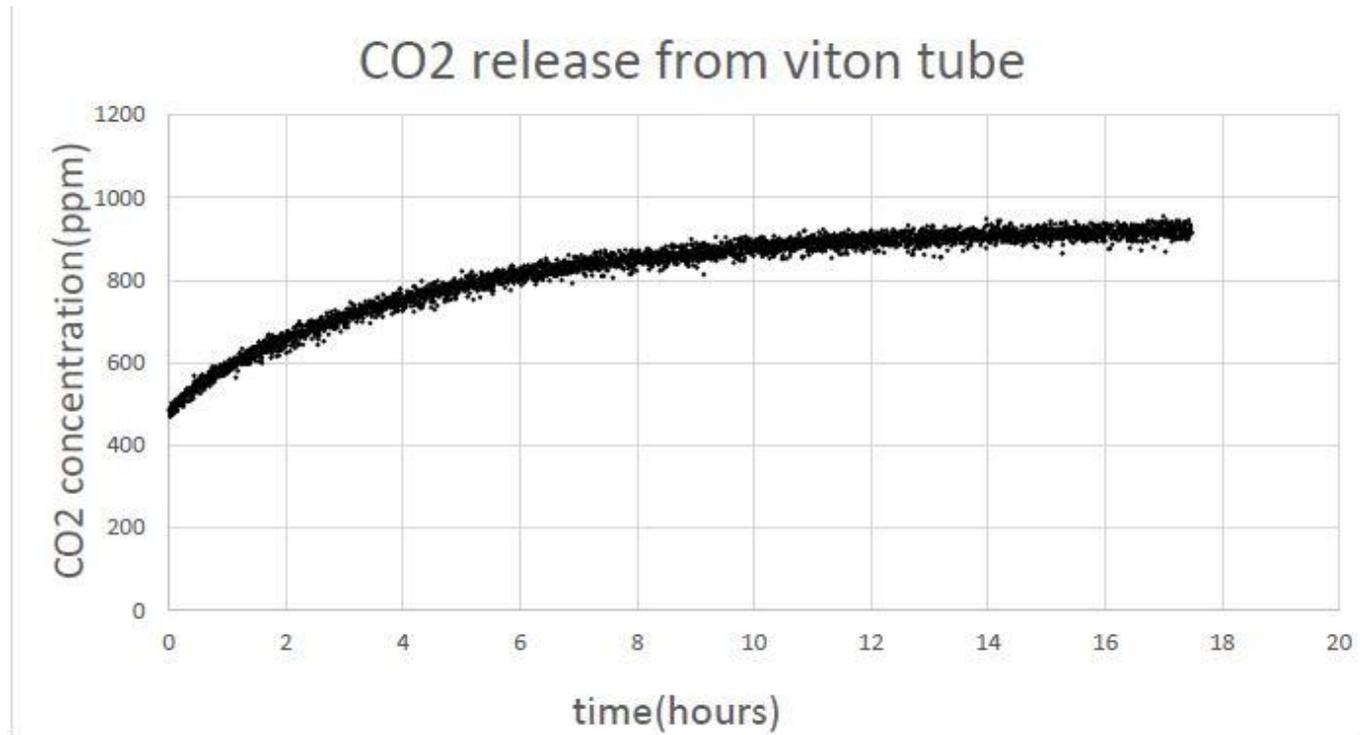
Viton desaturation result

- The result is from a saturated 70cm viton tube. Viton has been pressurized with CO2/Argon mixture for about a day.
- Viton should be desaturated after 24 hours.
- Because the viton was left for desaturation for 1~2 days before being used for the next measurement for st00215. Therefore the viton should desaturated before that. So The memory thing maybe not all result from the viton tube keeps bathing in CO2?

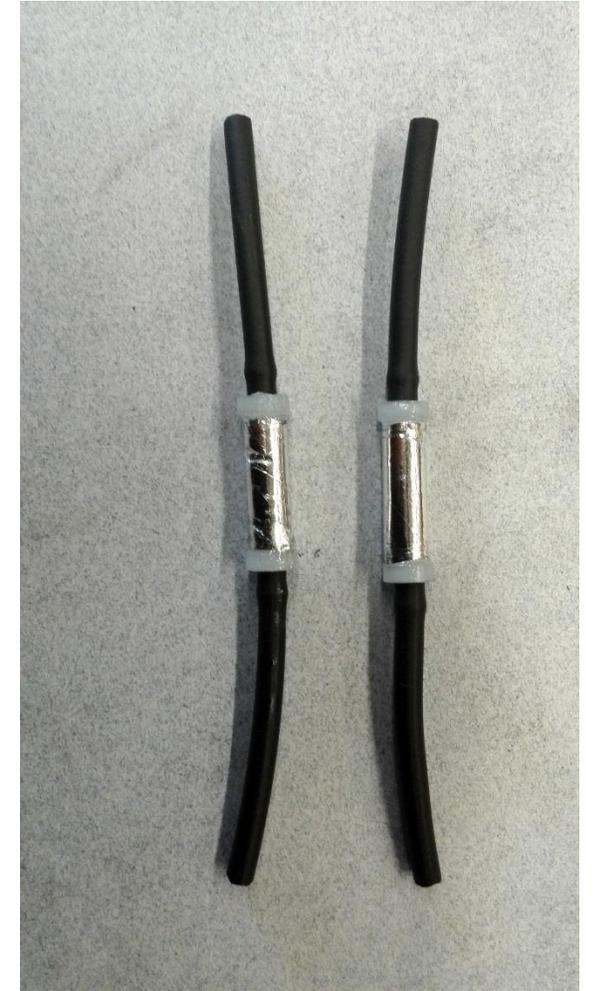
Short straws leak test results

straw number	leak rate* 10 ⁽⁻⁵⁾ ccm	uncertainty 10 ⁽⁻⁵⁾ ccm
#1	0.268	0.696
#2	0.692	0.684
#3	0.316	0.548
#4	0.872	0.548
#5	1.608	0.544
#6	0.012	0.544

- 6 short straws have been made for leak test the end part of straws.
- Each straw has the length of 16mm. After the end pieces been glued on the straw, there is no space between two end pieces.
- The result shows the leak from the Mylar is the major part of the CO2 leak
