Fermilab Mu2e status update

Daniel Ambrose

6/19/2015

Fermilab Status

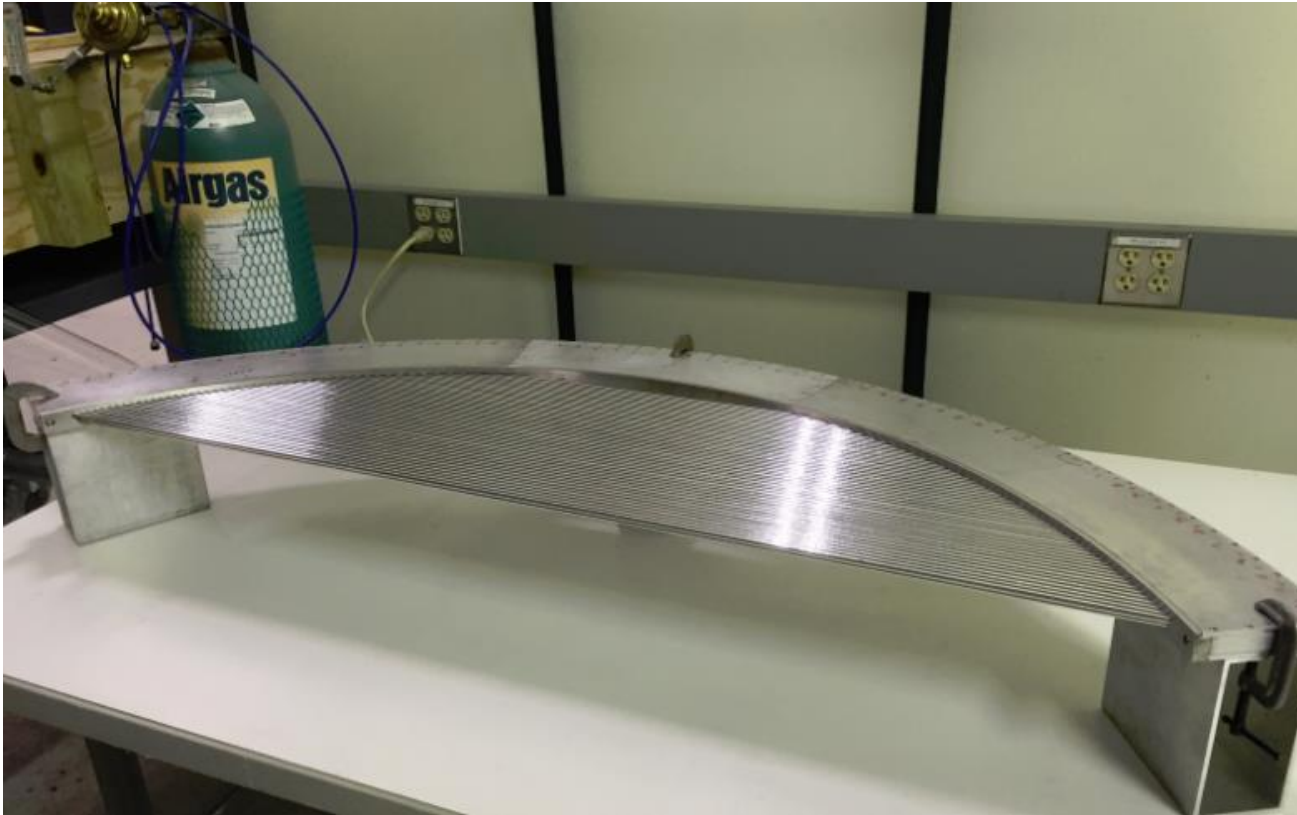
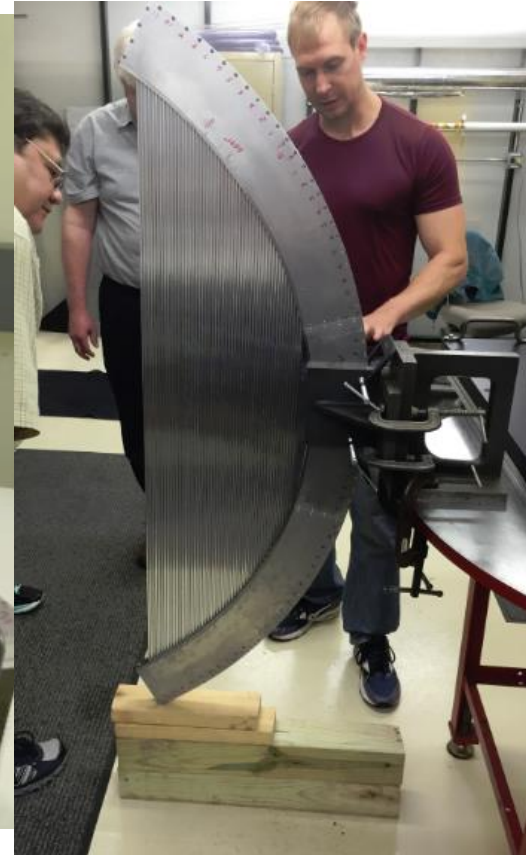
Panel 1.5 status

Tested for leaks with P5 gas. Result was ~4 straw end leaks and a crack leak on the manifold glue from when manifold was clamped. Re-epoxied straw ends from the other side and manifold joint. Will test for leaks again on Monday and move toward vacuum test.

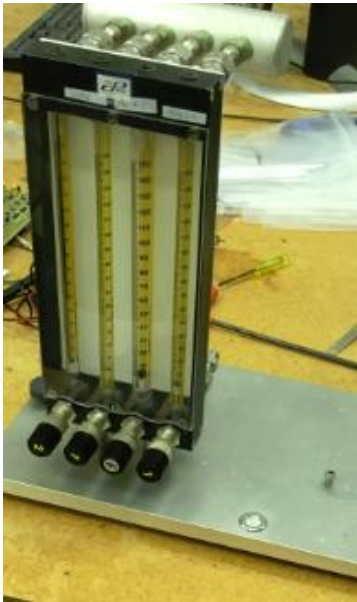
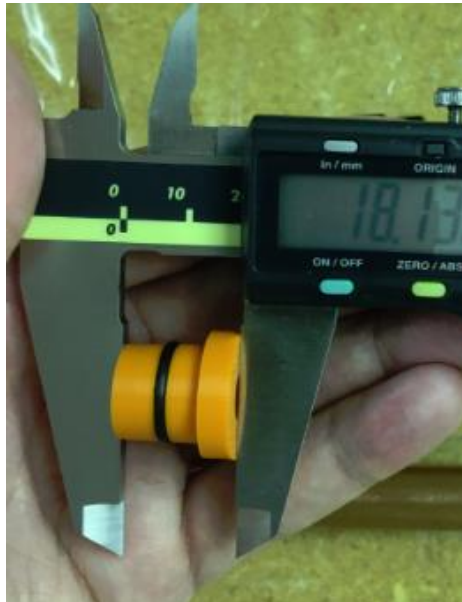
Leak Chamber status

Prototype calibration plug looks good, some changes needed.
