Fermilab Mu2e update

Outline

- CO₂ Leak testing
- Straw laser cutting
- Panel 1.5 status
- Panel 2.0 status

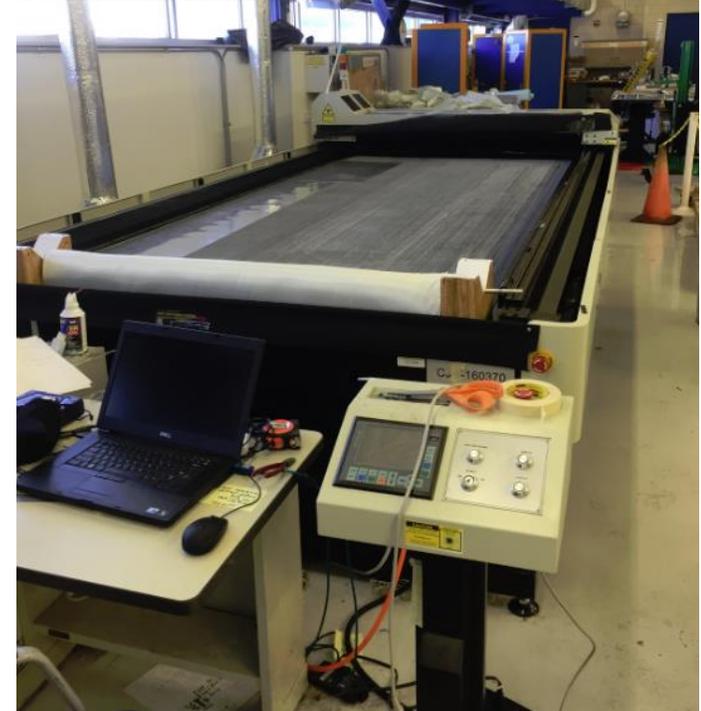
Fermilab Laser cutter

Model CJG 160370

- 10,640 nm wavelength
- 5 mm diameter
- 50.8 mm focal length lens
- 100 W
- 3700 mm x 1600 mm bed with built in exhaust
- ~\$50,000 machine

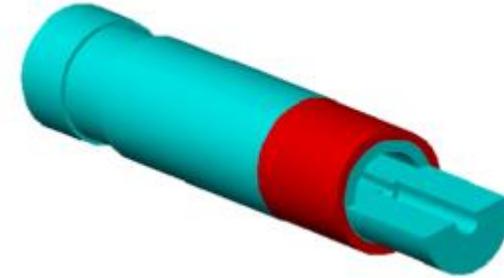
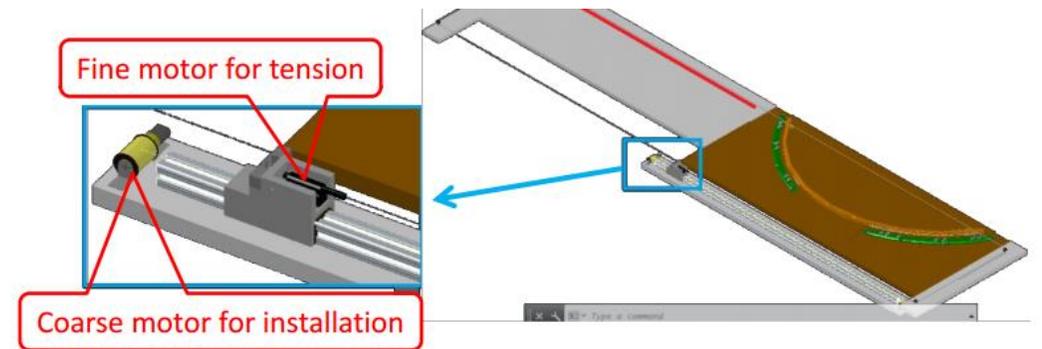
- Hopefully leak testing. Might start by using old leak test ends as new ones won't arrive til April 28th.
- Will be laser cutting straws.
- Haven't seen the new end pieces(upper right).
- Motor installation of straws and tensioning(bottom right)
- New Panel plate is being made to fix heating issues and incorporate other changes. Panel never goes vertical.(opportunity for us to install leaders before shipment)
- Completion estimate: End of Summer 2015.
